Property ID # 2724 / 3742 High Street

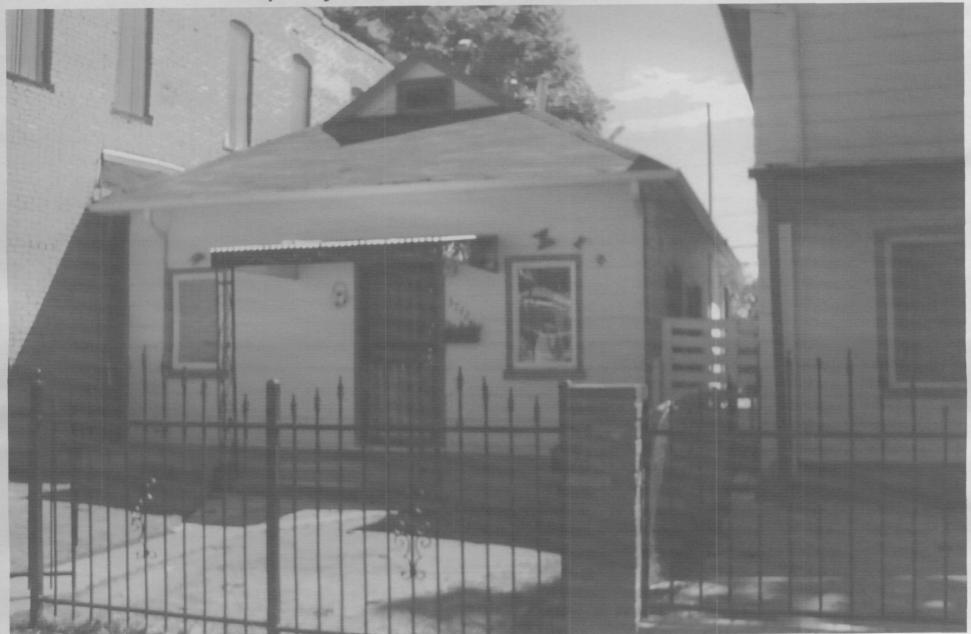
West exposure of property; house has new paint throughout
